PRINCE GEORGE'S COUNTY, MARYLAND
FIRE/EMS DEPARTMENT

Investigative Report House Fire with Subsequent Injuries 87 Herrington Drive

Wednesday, April 8, 2009
Box 4601

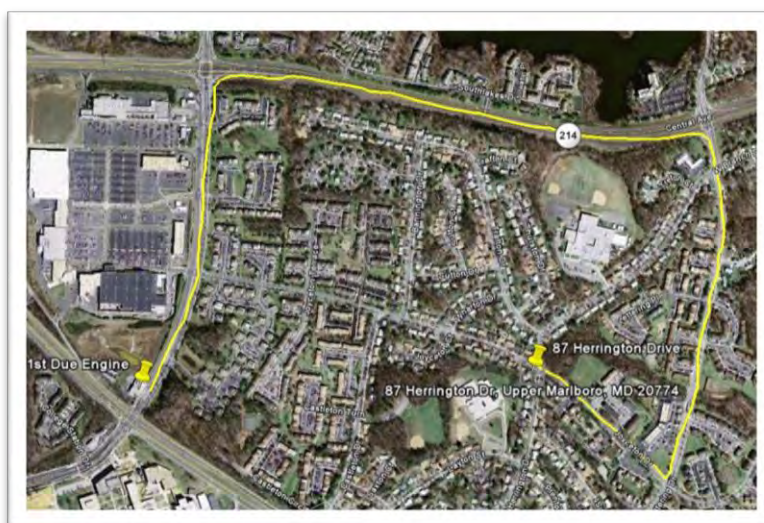
Using common online mapping software the chosen response route is calculated as 2.2 miles with an estimated six minute arrival time (See Figure 1.). The shortest route is calculated as .8 miles with an estimated arrival time of two minutes (See Figure 2.) (Google, 2009).

Figure 1. Response route of the First Due Engine Company calculated as 2.2 miles with an estimated travel time of 6 minutes.

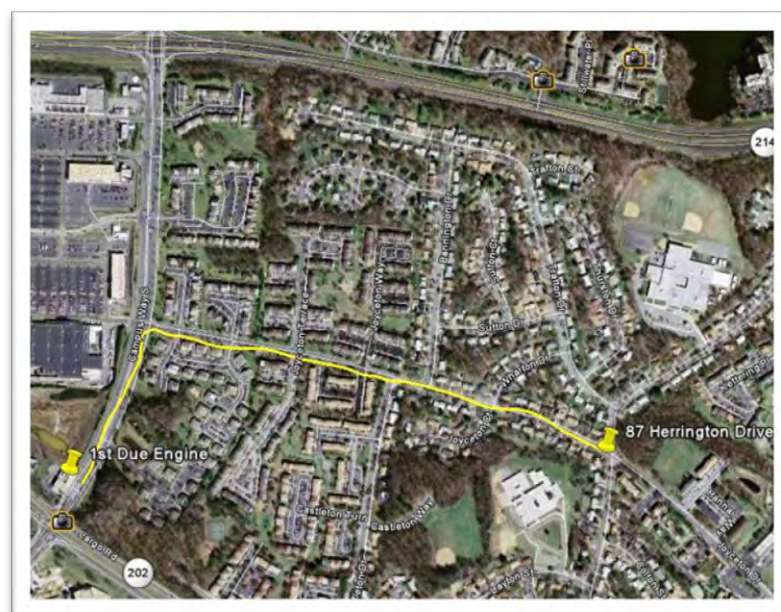
Figure 2. Closest available response route for the First Due Engine Company is .8 miles with an estimated travel time of 2 minutes.

Using the estimate of fifteen seconds per speed bump, the estimated response time for the chosen response route would be six minutes and thirty seconds while the shortest and recommended route would be three minutes and fifteen seconds. The response route of the first due engine increased the amount of time from dispatch to arrival allowing the fire to grow in intensity.

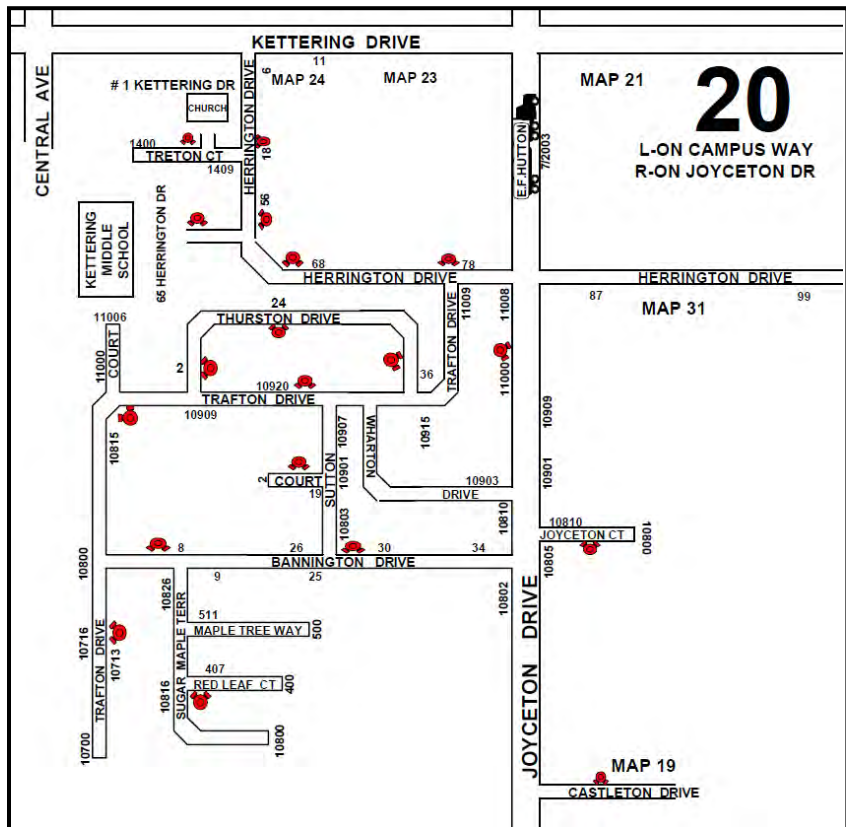
the supply line to the intersection after positioning the engine rather than stopping to layout. The closest available hydrant was three hundred and fifty feet away at 11000 Joyceton Drive. This hydrant was later utilized by the third due engine company. A hydrant located at 11201 Joyceton Drive was within four hundred feet but not listed on the map page. The first due engine went past this hydrant on their running route.

Figure 3: Map page #20 showing street configuration and hydrant location for 87 Herrington Drive. Note the running route listed under the page number. Hydrant at 11201 Joyceton Drive, 400 feet from the intersection, is not listed on this map.

- **The fire department should explore the use of available technology to replace station level hand drawn maps for navigation and water supply.**

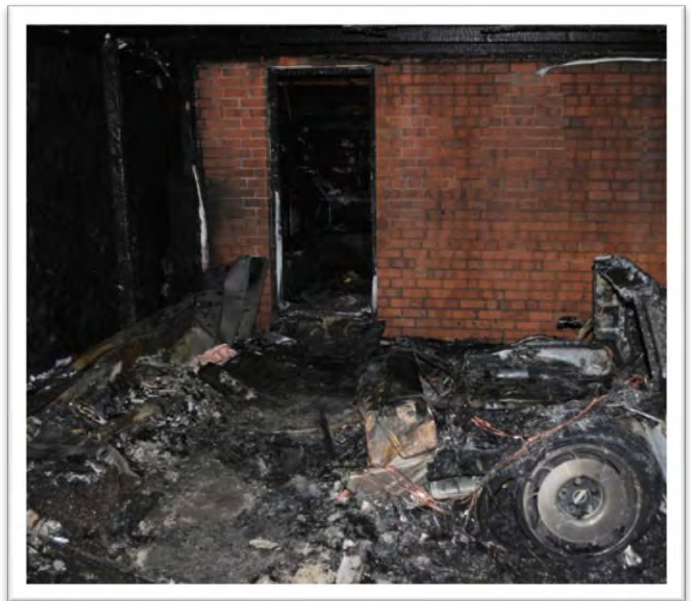
The fire had originated in an automobile in an attached carport of a single family detached house. The fire extended to the interior of the house through a wooden exterior door leading from the dining area into the carport. Additionally, fire had spread to the roof structure of the carport and was extending into the second floor of the home. The fire was later determined to be the result of arson by Fire Investigators from the PGCF/EMSD Fire Marshalls Office.

Figure 6: Side Bravo door leading from carport to interior of the structure.

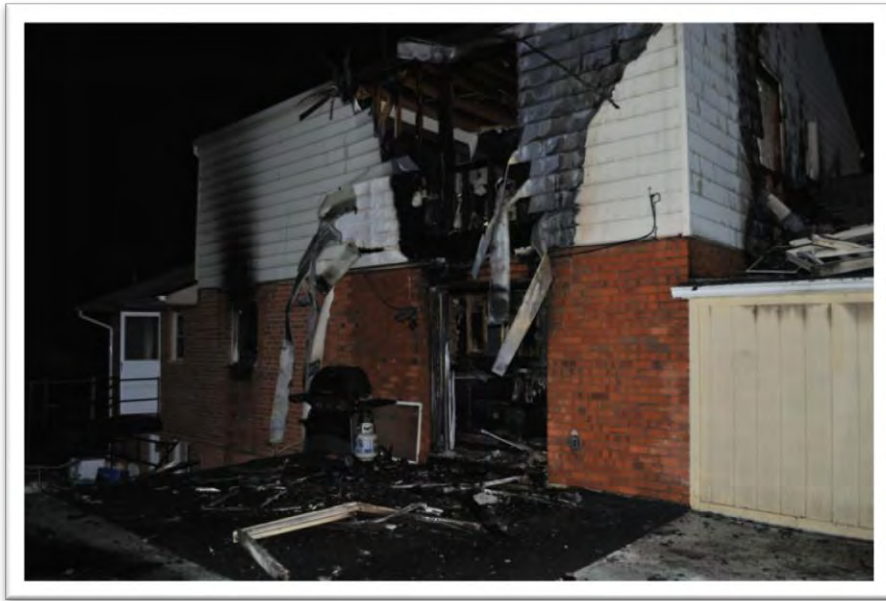
² Heat from the fire caused the glass in the door to shatter and fail, quite possibly when hit by water from the first hose line. The officer from the third due engine was the first to reach side Charlie and reported fire showing from this opening when he arrived.

Figure 7: Side Charlie showing the french door leading to the dining room/kitchen area.

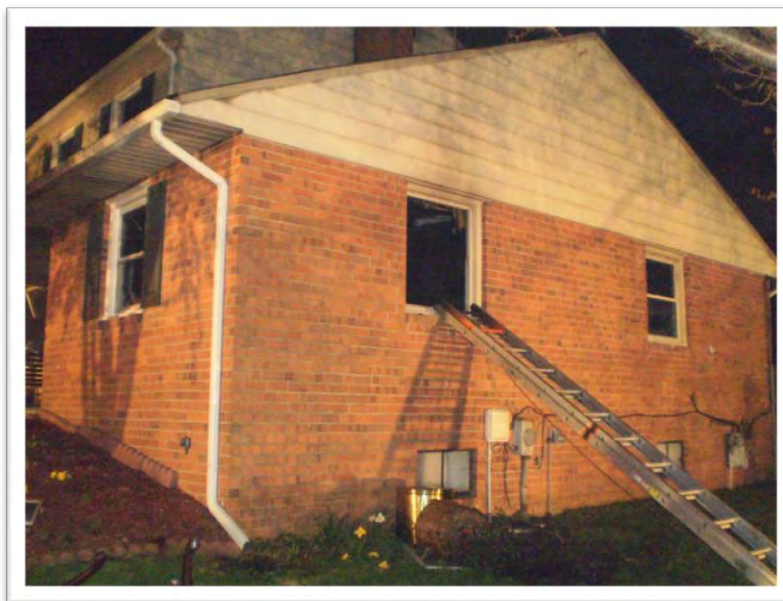
The injured fire fighter is removed, by way of the window on side Delta, and down a ground ladder. He is reported to be unconscious during his removal but regained an altered level of consciousness once on the ground. The EMS units dispatched on the working fire dispatch, along with the EMS supervisor arrived on the scene as the fire fighter was removed. EMS care was started immediately followed with rapid transport to the Washington Hospital Burn Center.

Figure 8: Side Delta showing the window, and the ladder placement where the fire fighter was removed.

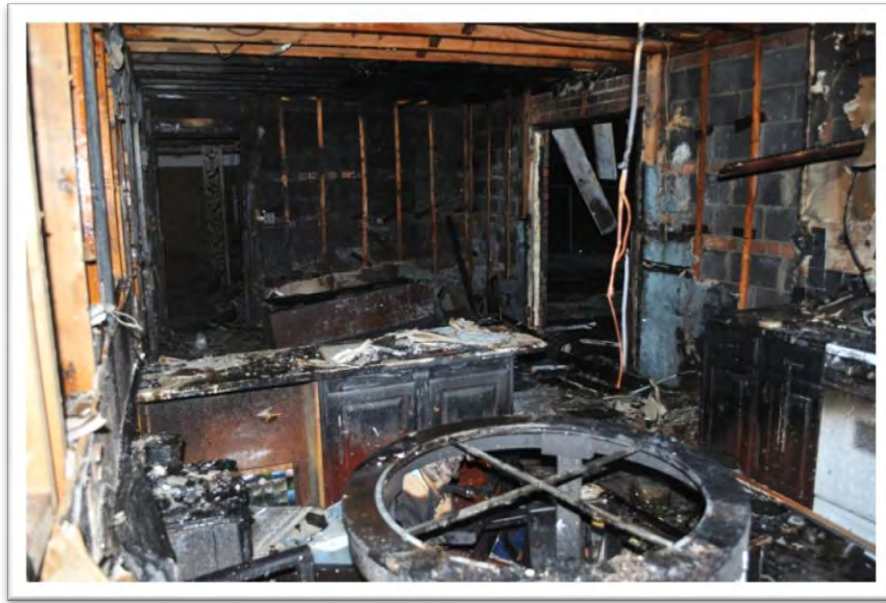
The charring at the ceiling level indicates that the carbon laden products of combustion ignited at the ceiling level. This produced an extreme fire condition in the area the fire fighters were operating. The extreme condition was exacerbated by the incomplete products of combustion from the burning auto and limited ventilation of the fire structure during the initial phase of operations.

The most seriously injured fire fighter was struck by an object, which is believed to be a ceiling fan, and became disoriented in the high heat and zero visibility. By his own account, he stood completely upright and attempted to find the exit. It is most likely that this is the point he received the burns to his face, neck and to some degree his respiratory track.

**Figure 9: Kitchen area where injured fire fighters received burns.
Note the hanging wire from the ceiling fan.**

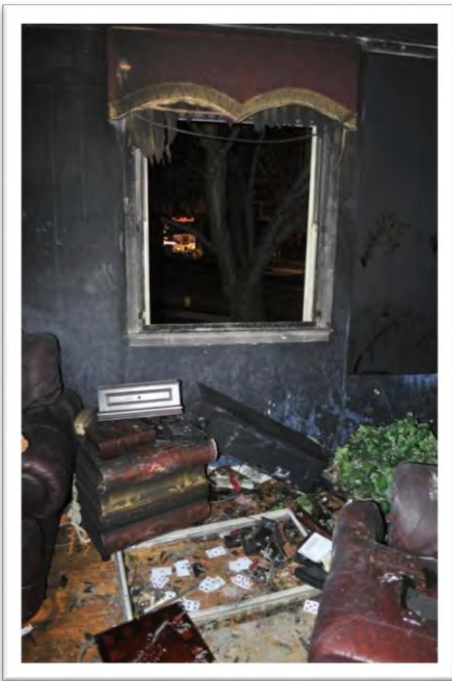
Hand prints and sweep marks on the walls suggest the fire fighter searched frantically for an exit along the fireplace surface and along the walls on sides Alpha and Delta. Marks on the walls indicate that the fire fighter was within one foot of the window that he was eventually rescued from. He was found unresponsive in this room with mask, helmet, hood and gloves removed.

**Figure 10: Interior view of window
fire fighter was removed from.**

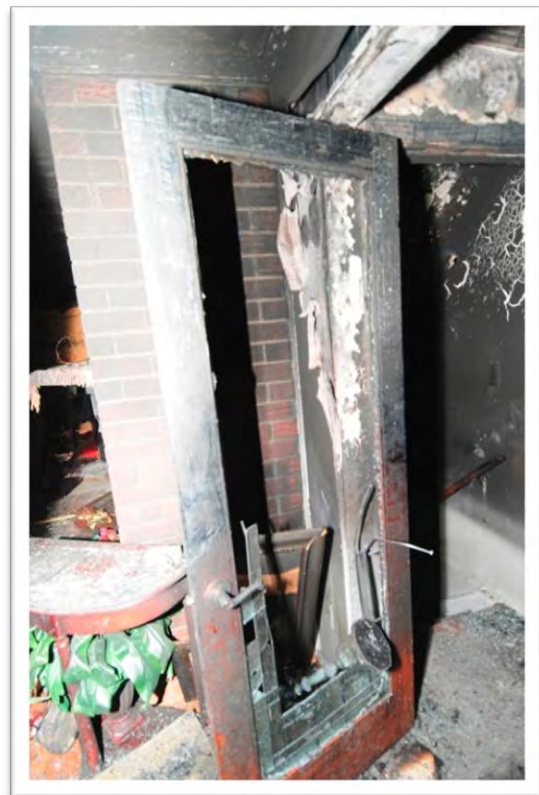
Fire fighter 1 left contact with the attack line and frantically searched for an exit. In the process he passed beside an outward opening glass door which leads to the basement. After passing the door way he felt a brick wall with his right hand. Feeling the brick led him to believe that he was outside of the structure and he proceeded to remove his helmet, hood, and SCBA face mask, which was now encased in thick black soot. Immediately inhaling smoke, he realized that he was still inside the structure but was unable to re-don his SCBA face mask and PPE. Recognizing that he was in distress, fire fighter 1 called verbally for help prior to losing consciousness as a result of inhaling carbon monoxide and other toxic byproducts of combustion. It is believed that fire fighter 1 frantically moved around the family room, dislodging items of furniture searching for an emergency exit prior to losing consciousness.

**Figure 11: Door to the basement steps that were
misidentified as the front door by the injured fire
fighter.**

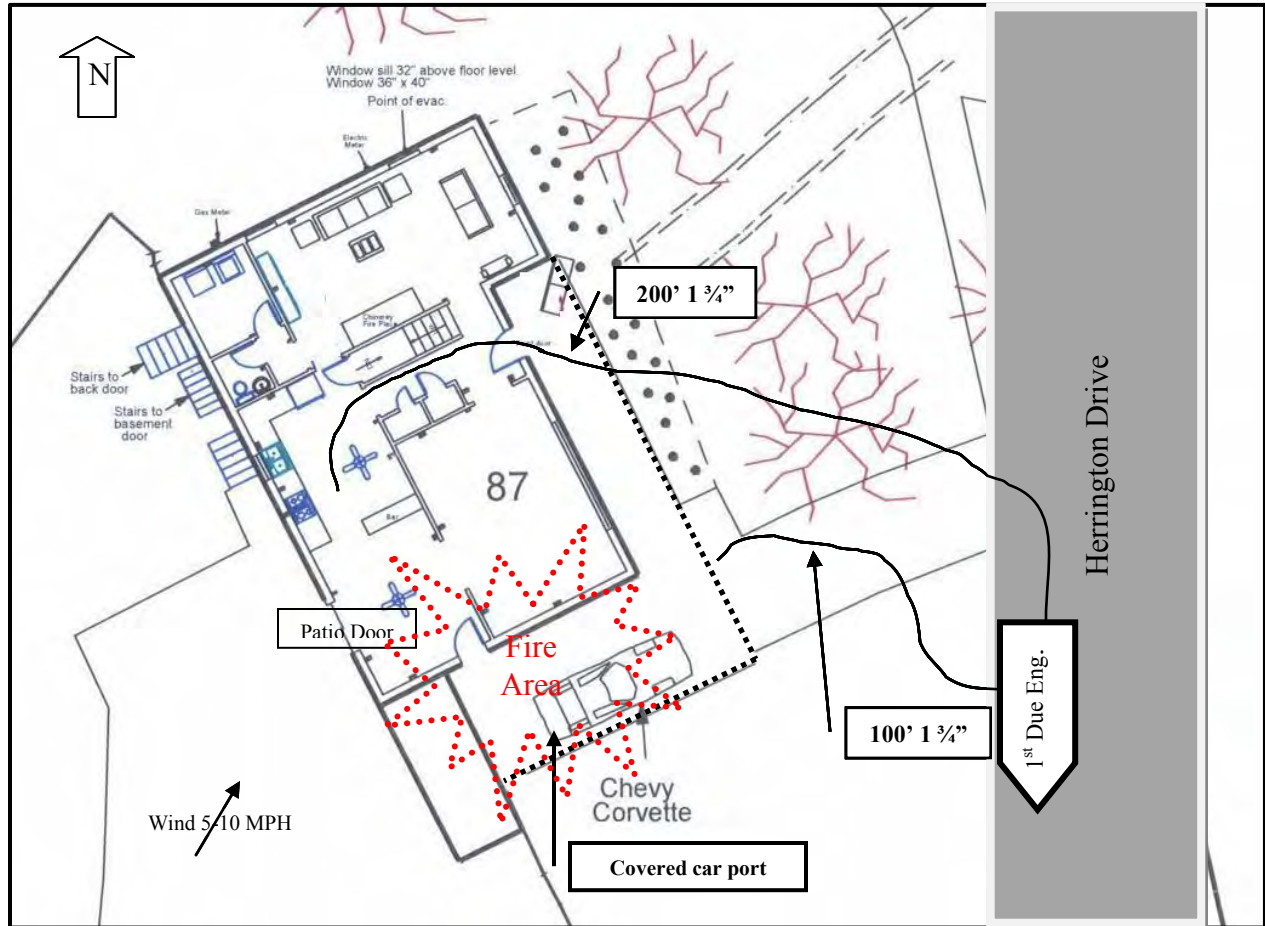
Figure 12: Layout of first floor with initial hose line placement.

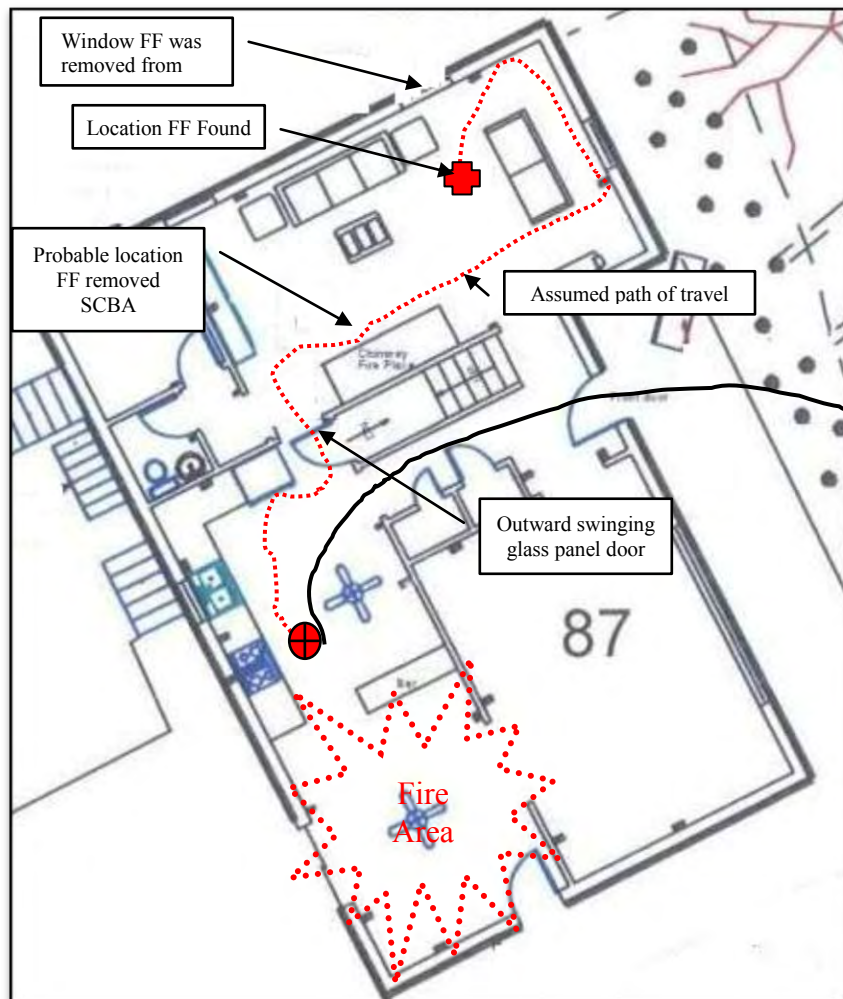
Figure 13: Layout of interior with assumed path of the most seriously injured fire fighter.
